REPAIR WORKS OF VARIOUS BUILDINGS DAMAGED BY THE TYPHOON KARDING

CCS BUILDING REPAIR WORKS

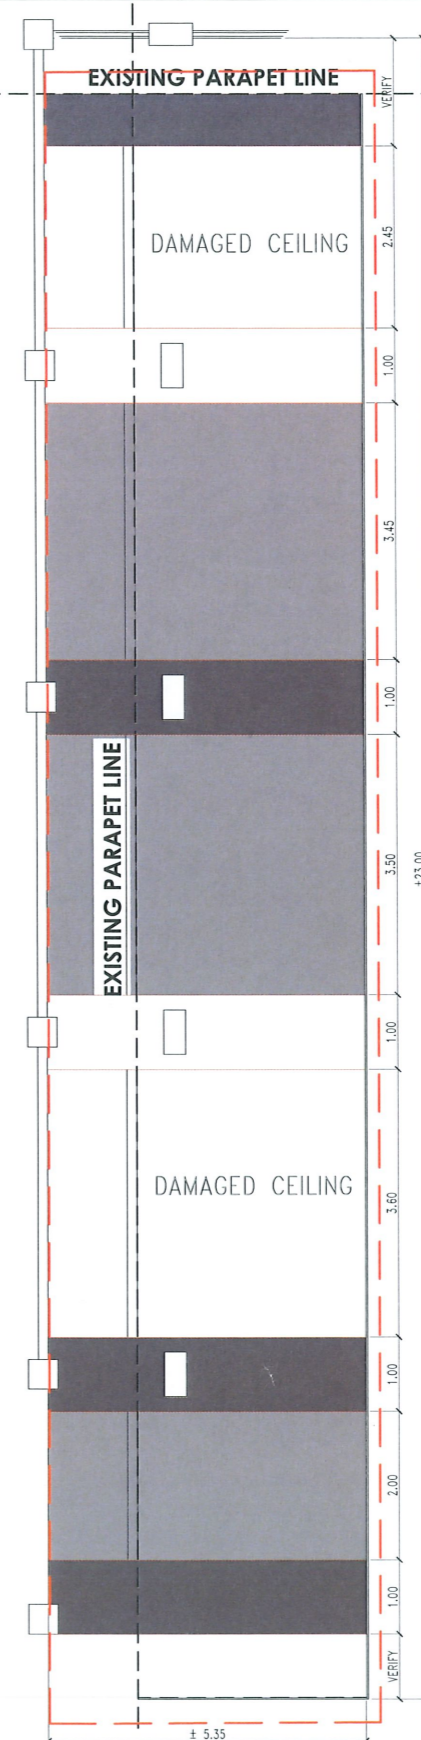
EXISTING CONDITION

LOCATION: RAMP CEILING @ 5TH FLOOR
(CCS BUILDING LEFT WING)
