REPAIR WORKS OF VARIOUS BUILDINGS DAMAGED BY THE TYPHOON KARDING

CCS BUILDING REPAIR WORKS

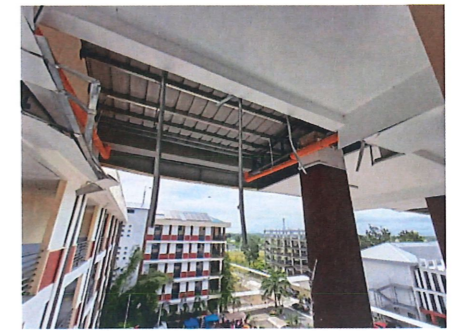
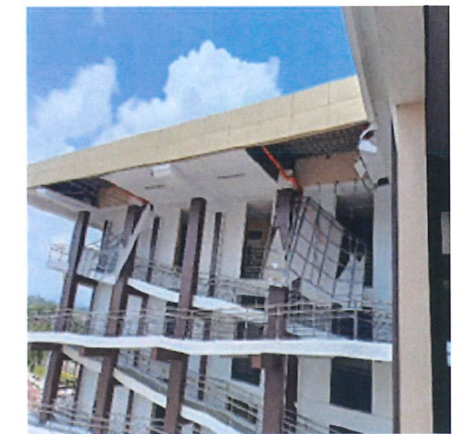
EXISTING CONDITION

LOCATION: RAMP CEILING @ 5TH FLOOR
(CCS BUILDING LEFT WING)

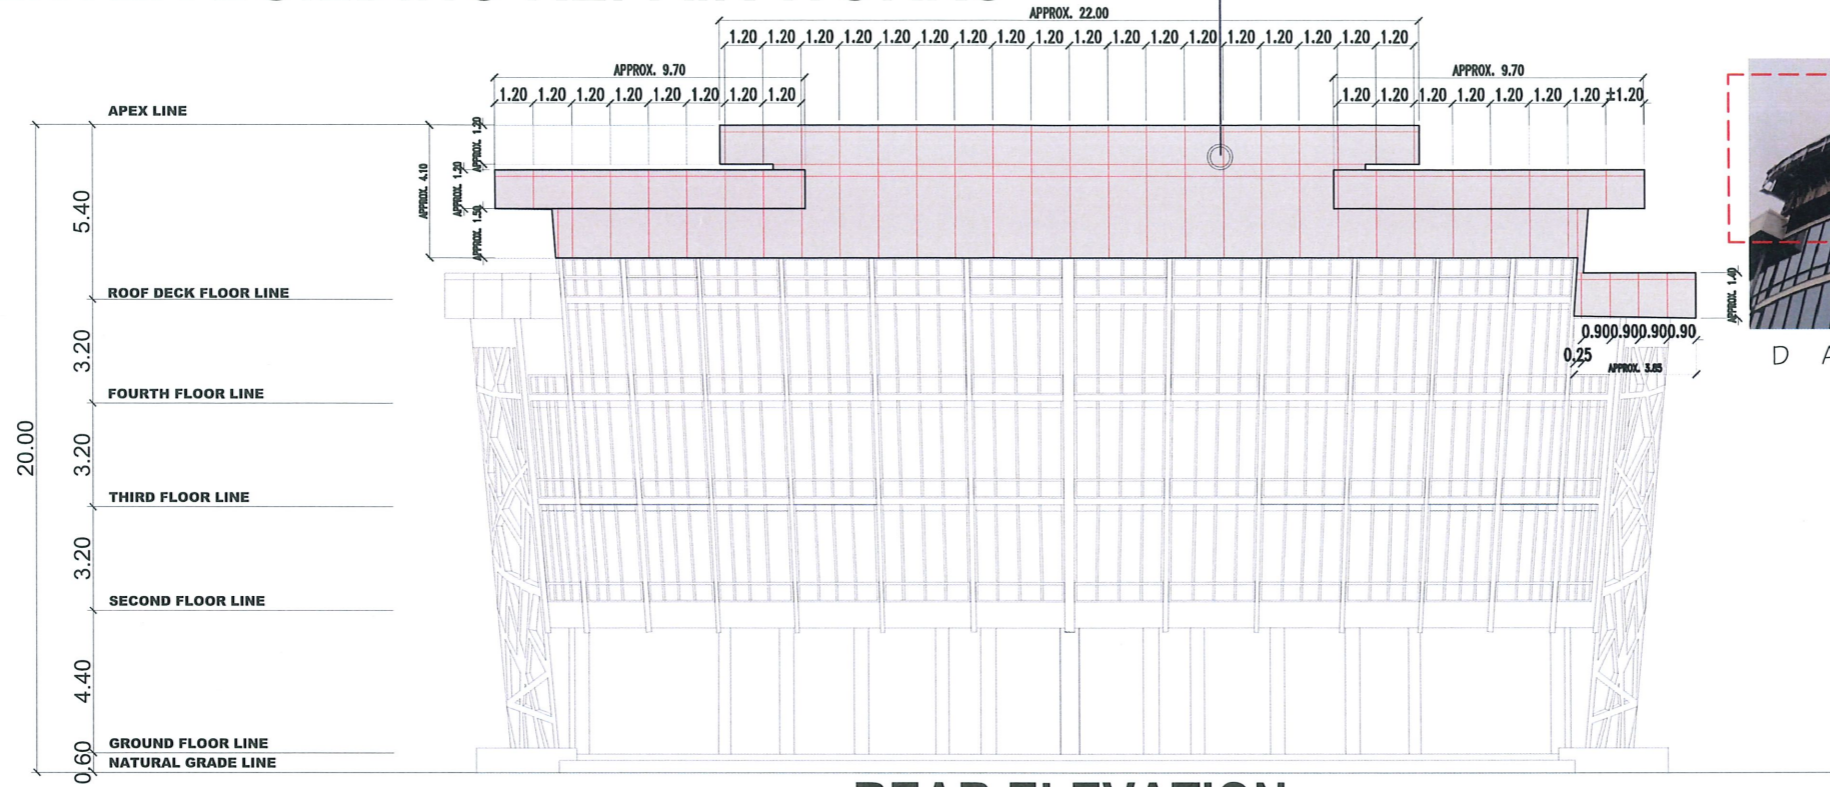
REAR ELEVATION

D A M A G E D A R E A

REPLACEMENT OF EXISTING ALUMINUM COMPOSITE PANEL (MATCH WITH THE EXISTING ACP COLOR) WITH TRI-FOLD BLIND RIVET SPACED @ 0.30M (CLADDING E VERIFY ON ACTUAL)
